Metallographic Characterization of Thermal Damage in Boiler Tubes

Michael P. Carroll¹

¹ Lisin Metallurgical Services, Portland, OR USA

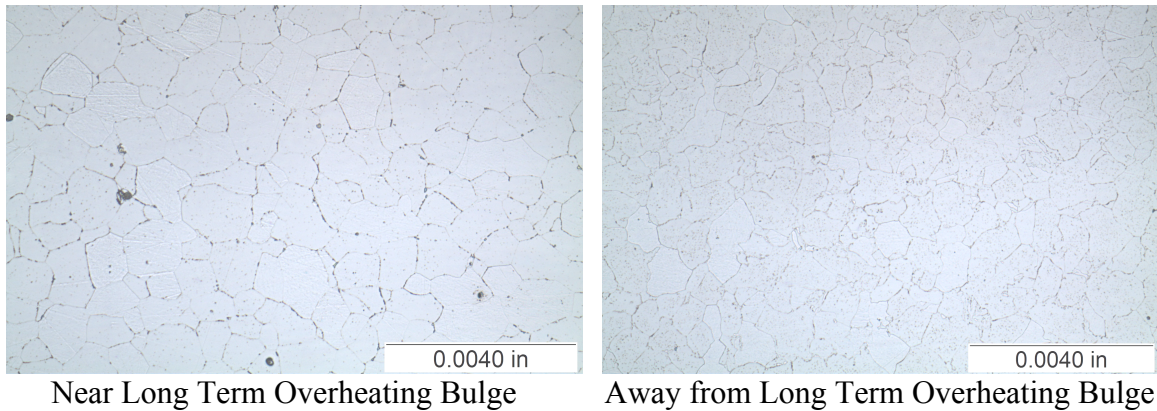
Figure 1: Optical photomicrographs showing metallographic cross sections taken at (left) and away from (right) long term overheating damage. Both microstructures are ferritic, but creep void formation along grain boundaries is apparent in the overheated area. Fractography of the main fracture surface revealed a predominately intergranular pathway. 2% nital etch.

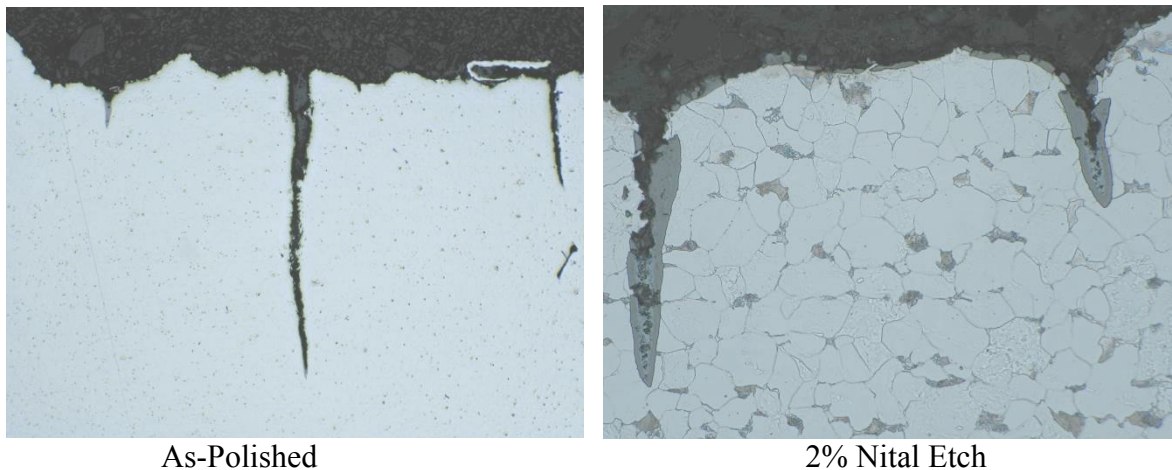
Figure 2: Optical photomicrographs showing longitudinal sections through adjacent cracks. The straight, unbranched, wedge shaped cracks are characteristic of thermal fatigue. The microstructure of the tube consisted of lamellar pearlite in a ferrite matrix. Evidence of overheating damage was not revealed by the metallographic examination. As-polished (left) and 2% nital etch (right).
