Cross-sectioning Sub-millimetre Sized Defects in Ornamental Chrome-plated Component

A.J. Lockley¹

¹ Canadian Nuclear Laboratories, Chalk River Labs, Chalk River Ontario Canada

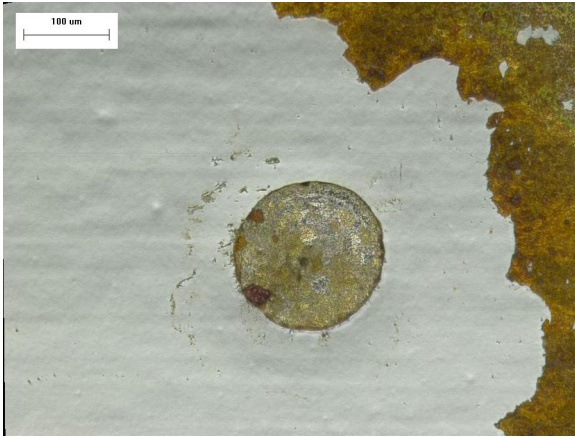
Figure 1 Digital Microscope image showing a circular defect with surrounding rust-coloured staining on a chrome plated surface.

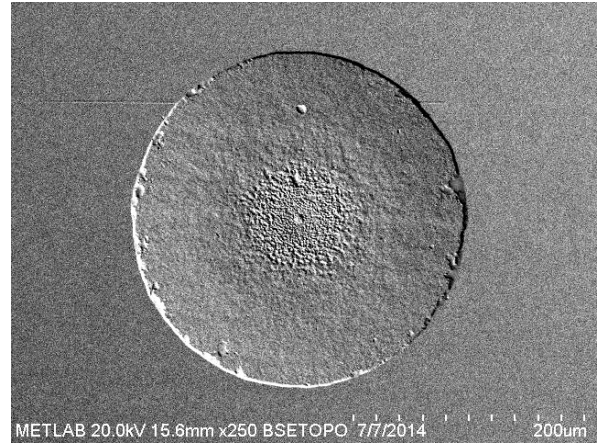
A digital microscope (DM) in conjunction with a Scanning Electron Microscope (SEM) was a synergistic tool set effective in locating and imaging small surface defects. The DM is a recent evolution of the optical microscope that was particularly useful for its ability to scan wide fields of view at lower magnification with the ability to zoom to higher magnification without having to change objective lenses while maintaining superior depth of field compared with standard optical methods. This instrument proved invaluable for the detection of small circular defects frequently associated with surface stains as seen in Figure 1. Circular defects were examined using the SEM to obtain higher resolution images as seen in Figure 2. The circular defects ranged in size from about 100 μ m to 200 μ m in diameter.

Figure 2 An SEM image showing detail of one of the circular defects.

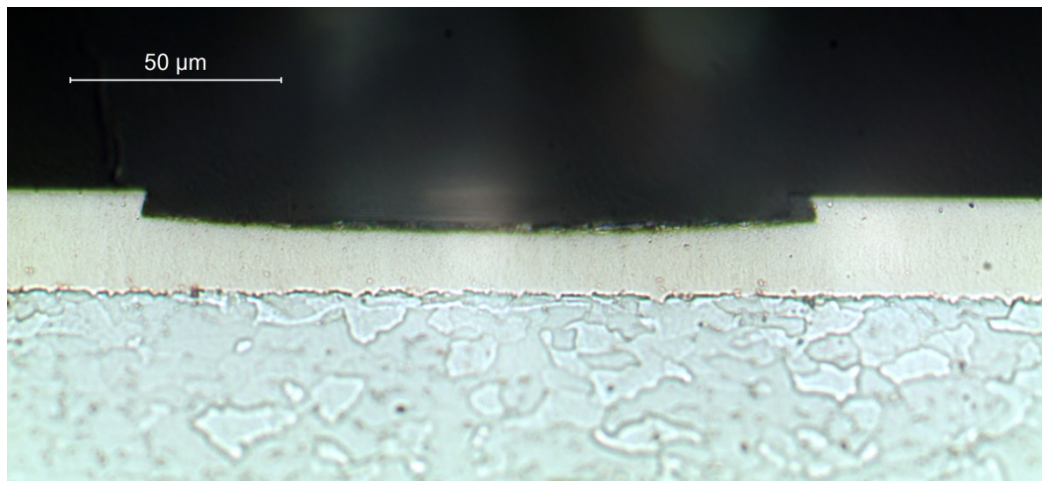
Visually aided serial-sectioning was successful in producing metallographic cross-sections through the centre of the circular defects. This revealed that circular defects tended to be isolated to the outer surface of the nickel plating and if they occurred in a region where the nickel plate was sufficiently thick the defects had limited depth as seen in Figure 3. However, in regions where the nickel plate was relatively thin, a pit in the steel substrate was commonly observed as seen in Figure 4. The circular nature of the defects suggest they result from the presence of gas bubbles that prevented a uniform coverage of the surface. Corrosion to the steel substrate would occur in areas where nickel plating thickness was inadequate to provide corrosion protection. As corrosion progressed the corrosion by-products seeped out of the pit and stained the chrome surface.

Figure 3 Cross-section of the profile of a circular defect in the nickel plate on a steel substrate.

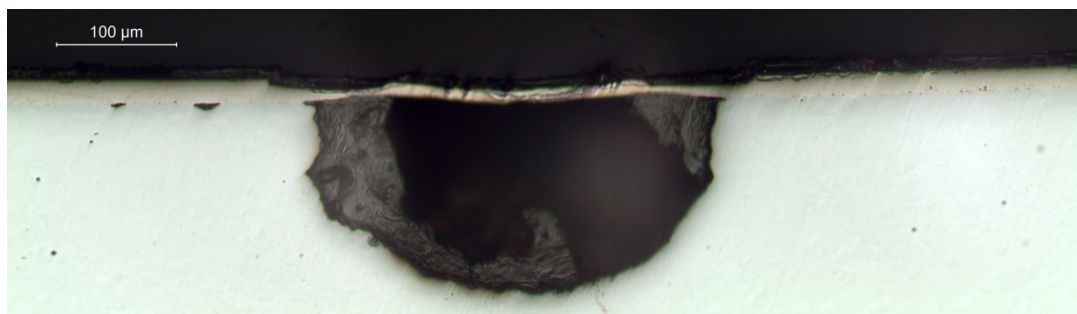
Figure 4 Cross-section through a circular defect with a corrosion pit beneath.
