## **Metallography – A Powerful Instrument for Material Characterisation, Material Development and Failure Analysis**

Michael Panzenböck<sup>1</sup>, Francisca Mendez-Martin<sup>1</sup>, Boryana Rashkova<sup>1</sup>, Patric Schütz<sup>1</sup>

<sup>1</sup> Department of Physical Metallurgy and Materials Testing, Montanuniversität Leoben, Austria

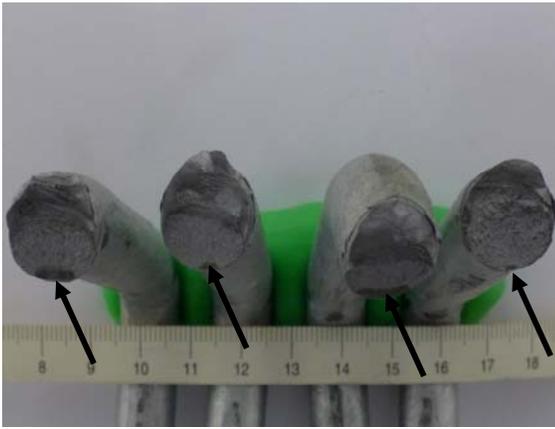
Figure 1 shows an overview of broken supports. Macroscopic investigations reveal dark spots within the crack surface. This indicates that such defects were responsible for the failure of many supports. Further investigations revealed [2] that the area of crack initiation was covered with Zn, which originates from hot dip galvanization. A cut through such broken and unbroken parts in longitudinal direction revealed cracks covered with Zn (Fig. 2). The light-optical micrograph shows the Zn-layer followed by the microstructure of the steel, which consists of ferrite and a small amount of pearlite, as can be seen far away from the Zn-layer. However, it seems that regions near the Zn-layer exhibit a nearly pure ferrite structure. This can be attributed to an effect of decarburisation. The “ferritic” microstructure is caused by the cathodic protection due to zinc during etching with Nital-solution. In this case the cracks can be attributed to a liquid metal embrittlement (LME).

**Figure 1.** Macroscopic overview of the fracture surface. Arrows mark the region of crack initiation (dark spots).

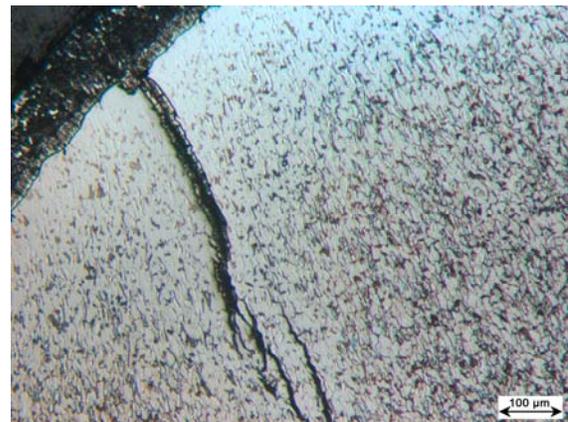
**Figure 2.** Light-optical micrograph of a crack after etching with Nital. The crack surface is covered with zinc.

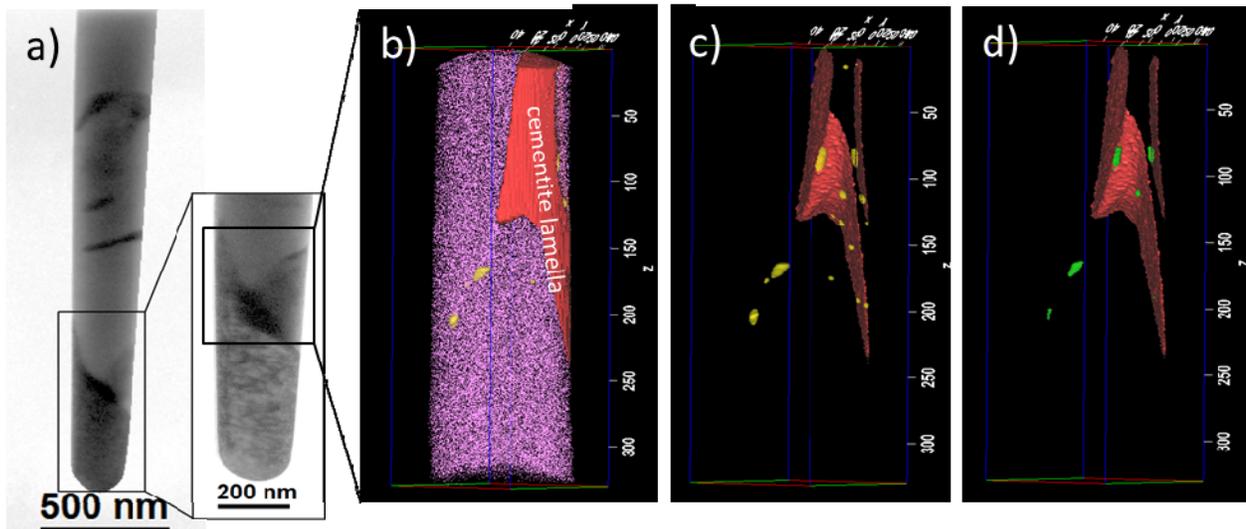
Between the years 2000 and 2010 many failures of steel constructions occurred due to LME. In many cases, polluted Zn, used for the hot dip galvanization process, was identified [3] as a trigger for LME. Elements such as Pb, Sn, and Sb were typically identified with high concentration of more 1 wt%. In this case, a content of less than 0.1 wt% was found. In contrast to the Zn layer, high concentrations of Cu (about 0.45 wt %), Sn (0.12 wt %) and Sb (about 0.1 wt %) were found in the steel used for the supports. It is not possible to detect local enrichments of these elements with standard metallographic methods. Therefore, we used APT to prove the enrichment of Cu and Sn on or near grain boundaries. The results

are shown in Fig. 3. The preparation of the tip (Figs. 3a, b) was made by using etching methods and subsequent milling by FIB. The process was controlled by electron back-scatter channelling diffraction (EBSD) to ensure that a grain boundary is in the investigated region. The grain boundaries are covered with precipitates of Cu and Sn (Figs. 3c, d). Additionally, ternary cementite is visible.

**Figure 3.** TEM images (a) of an atom probe tomography (APT) specimen (prepared by FIB) of a broken support. The results reveal fine Cu- and Sn-rich precipitates at the grain boundaries between a cementite lamella and the iron  $\alpha$ -matrix. Fe atoms are shown in pink (b), Cu isosurfaces in yellow and Sn isosurfaces in green. The grain boundary between the cementite lamella and the iron  $\alpha$ -matrix is indicated in red color in (c) and (d).
