Advanced electron microscopy study of fission product distribution in the failed SiC layer of a neutron irradiated TRISO coated particle

Haiming Wen¹, Isabella J. van Rooyen¹, John D. Hunn², Tyler J. Gerczak², Charles A. Baldwin², Fred C. Montgomery²

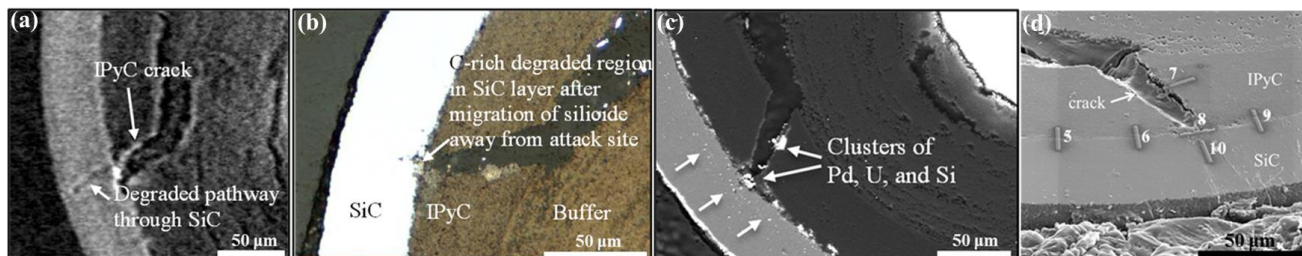
Figure 1. X-ray tomograph (a), optical micrograph (b), and backscattered electron composite image (c) showing localized degradation from Pd and U attack of the SiC layer where it was exposed by an IPyC crack; (d) SEM image showing locations where STEM lamellae were sectioned.

During post-irradiation examination of TRISO particles from AGR-1 Compact 5-2-3, gamma-activity measurements determined that Cs had been released by two specific particles. The fractional Cs and Ag releases from one of the two particles, Particle 523-SP01, were determined to be ~30% and ~85% respectively. Non-destructive three-dimensional X-ray tomography performed on this particle revealed that the SiC failure was localized to one specific region. Figure 1 (a)-(c) shows x-ray, optical, and scanning electron microscopy (SEM) images of the SiC failure in this particle. The failure mechanism was found to be SiC degradation through chemical reaction with Pd and U initiating at a SiC inner surface exposed by IPyC fracture [3].

To further examine the failure mechanism, fission product distribution and transport, scanning transmission electron microscopy (STEM) specimens were prepared using the focused ion beam (FIB) technique. Figure 1(d) shows the locations where STEM lamellae were sectioned by FIB. STEM and energy-dispersive X-ray spectroscopy (EDS) were conducted. In lamella 7, all precipitates close to the crack are rich in Pd and Si, ~63% of which contain a small atomic concentration of U. Approximately 63% of the Pd-Si and Pd-Si-U precipitates contain Cs, with concentrations ~0.20–1.43 at%. No Ag is evident in any of the precipitates. Ce and Cs have very close peaks in the EDS spectra; because the TRISO particle had no detectable Ce release and significant Cs release, all of the overlapping Cs and Ce peaks are considered Cs peaks. Further examination using EDS with better energy resolution is underway to obtain more accurate Cs concentrations. In lamella 8, most precipitates are composed of Pd and Si, with ~50% also containing a small atomic concentration of U. Approximately 36% of the Pd-Si and Pd-Si-U precipitates contain Cs, with concentrations ~0.20–1.99 at%. Only one precipitate (out of 36) rich in Pd and Ag was found, with 5.34 at% Pd and 2.02 at% Ag.

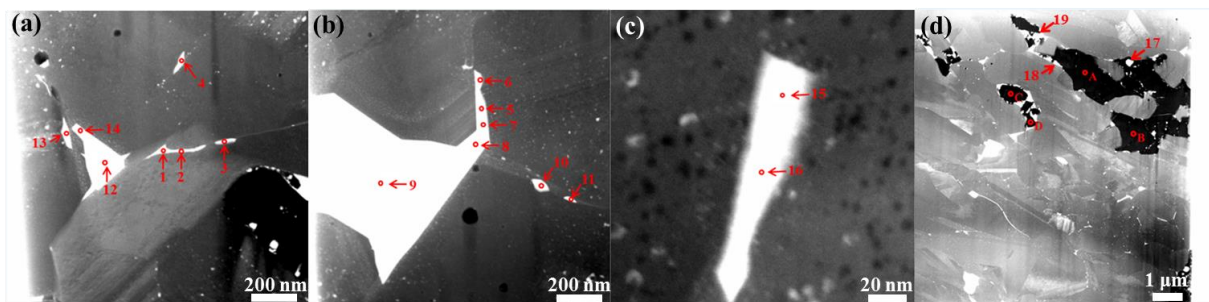
Figure 2. STEM images of STEM lamella 10 shown in Figure 1(d). Precipitates numbered and arrowed in (a)-(d) were subjected to EDS analysis. Dark areas in (d) are carbon, and letters A-D indicate locations for EDS analysis. Ag and/or Cd are detected in EDS point scans 1-8 and 15-16.

Figure 2 shows representative STEM images of lamella 10. In Figure 2 (a)–(d), precipitates numbered and arrowed were subjected to EDS investigation. Precipitates in the SiC layer are Pd-Si-U, Pd-Si, Pd-U or Pd. Approximately 30% of these precipitates contain Cs, with concentrations usually in the range ~0.40–0.80 at%, highest concentration being 2.20 at%. No precipitates containing only Cs were

observed. Ag and/or Cd containing precipitates were identified by EDS point scans 1–8 and 15–16 at grain boundaries or triple junctions. The Ag concentration in these precipitates is 0.22–7.95 at%, and the Cd concentration is 0.20–1.31 at.%. Ag and/or Cd may exist by themselves or coexist with Pd. The number of Cs containing precipitates is significantly higher than that of Ag or Cd containing precipitates; however, Cs concentration in the precipitates is usually significantly lower than Ag or Cd concentration. Dark areas in the SiC layer (Figure 2(d)) were identified by EDS to be pure carbon. Bright precipitates in the pure carbon areas (17, 18 and 19 in (d)) were identified to be Pd₂Si or PdSi. These results confirm chemical reactions between Pd and SiC, forming Pd₂Si or PdSi and carbon. Note that Cs containing precipitates were seldom found and no Ag or Cd containing precipitates were found in other lamellae sectioned from other locations in the SiC layer of this TRISO particle.
