Dynamic Rate Mechanism of V_2O_5 Coated SnO_2 Nanowires for Lithium Ion Batteries Studied by *in situ* TEM

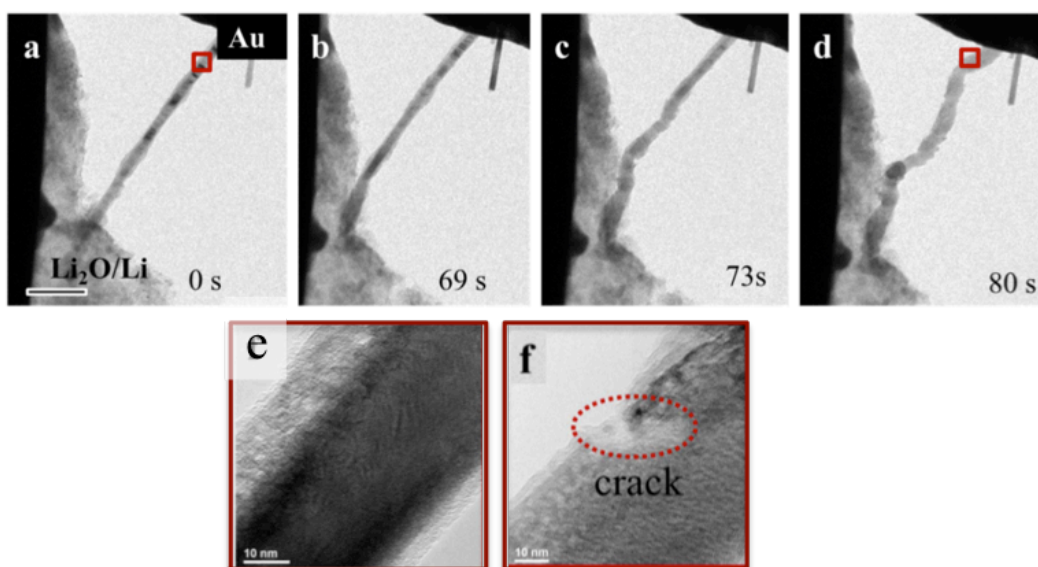
Figure 1. (a-d) Snapshots of SnO₂ nanowire during the first lithiation process at lithiation current of 300 pA. Cracks that form along the coating shell are visible in (d). (e, f) Bright field images of the same area before and after the first lithiation process as marked by the boxed area in (a) and (f) showing cracks forming in the shell of the nanowire.

The cells were set up with a single V_2O_5/SnO_2 nanowire as the cathode material and cycled in galvanostatic mode. TEM images of the lithiation process at a lower rate (300 pA) are shown in Figure 1. The bright-field images in Fig. a, b-d show the effect of lithiation on overall nanowire morphology, revealing lithium intercalation into the interlayer spaces of V_2O_5 with only a subtle volume expansion while in the core, lithium alloys with Sn, giving rise to ~200% volume change. As seen in Fig. 1, cracks in the lateral direction due to the volume expansion mismatch are observed, and these cracks appear to be the main cause for the capacity loss at low rate. A rather different lithiation process is observed at a higher rate (3 nA) as shown in Figure 2. At this higher rate, we observe Sn nanoparticles growing along the nanowire and the alloy reaction is retarded in the first lithiation process. Layered material V_2O_5 in the shell with inactive Li_2O in the core forms a more stable structure and active Sn nanoparticles aggregate along the stable nanowire, giving rise to a new nanostructure and better cycle life.

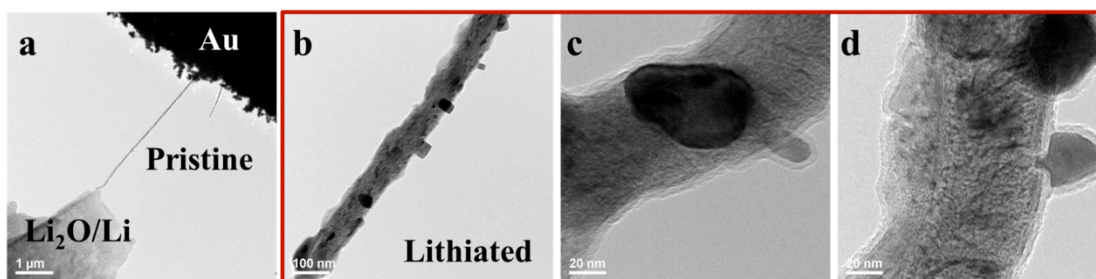
Figure 2. (a) Bright field image of a pristine V₂O₅/SnO₂ nanowire. (b-d) Images of the nanowire after the first lithiation process under 3 nA lithiation current showing Sn nanoparticles aggregating along the surface of the nanowire.

A comparison of the lithiation mechanisms revealed by this *in situ* TEM approach reveals new insight into the dependence of lithiation and delithiation on charging rate for these V_2O_5/SnO_2 nanowires. At low charge rates, lithium intercalates into the interlayer space of V_2O_5 in the shell and alloys with Sn in the core. Mismatch in volumetric expansion between the lithium intercalation- V_2O_5 compound and the lithium alloy- SnO_2 causes mechanical fracture in the core/shell nanowire. The volume expansion of crystalline SnO_2 is confined in the lateral direction by the V_2O_5 surface coating. This results in crack formation along the coating surface, which leads to capacity fade. In contrast, at higher rates, the alloy reaction of Sn with Li to form Li-Sn is retarded, and Sn particles that are the active host for Li aggregate on the surface of the host nanowire, minimizing deleterious effects of volume expansion and providing much better cycle performance.
