Testing – Device Problem Analysis

Dr. Lynn Fuller

This document is a collection of test results showing problems with various semiconductor devices made in the microelectronics fabrication laboratory. The objective is to provide useful information for identification of the source of problems and to enhance the education of our students.

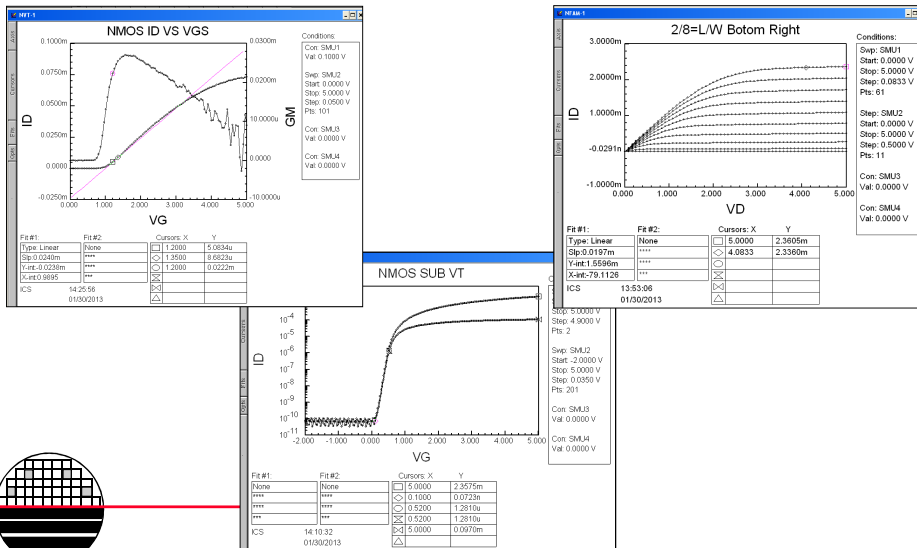
GOOD NMOS DEVICE CHARACTERISTICS

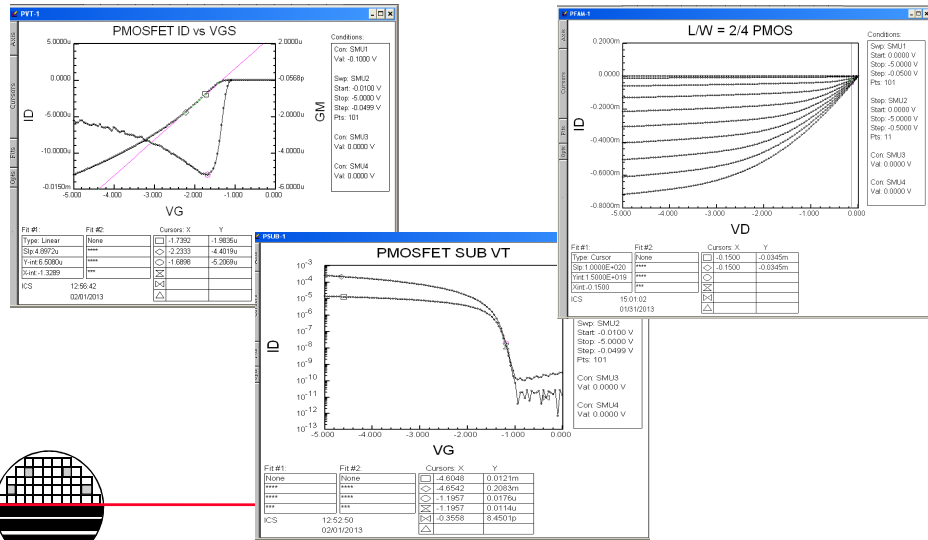
GOOD PMOS DEVICE CHARACTERISTICS

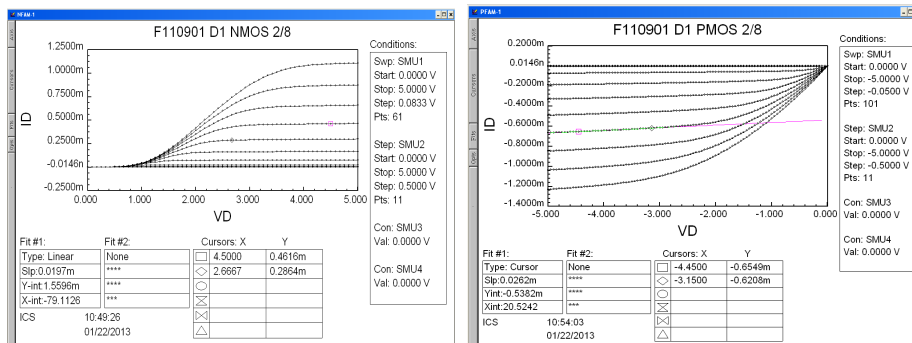
NON OHMIC CONTACT TO NMOS DRAIN/SOURCE IN SUB-CMOS PROCESS

Over etched contact cuts makes a non-ohmic (rectifying or Schottky) contact with the lighter doped n-type area of the drain/source. P-type devices have ohmic contacts.

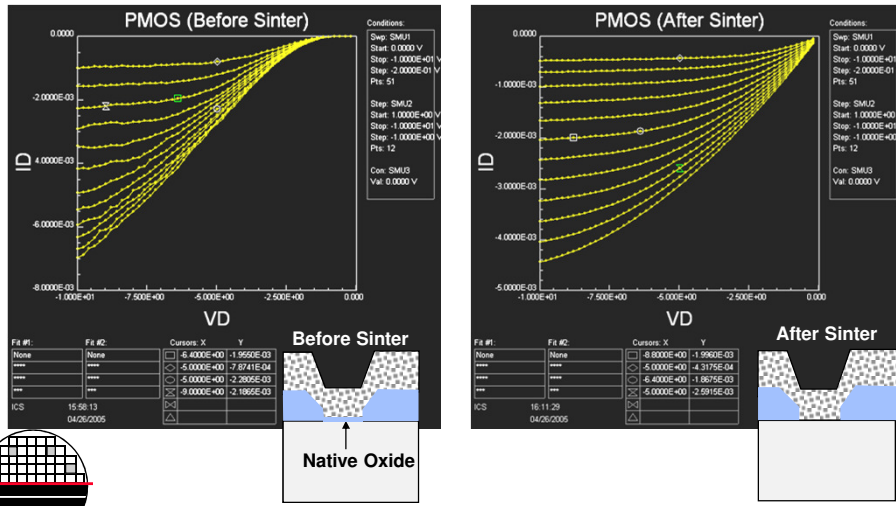
EFFECT OF SINTER ON IV CHARACTERISTICS

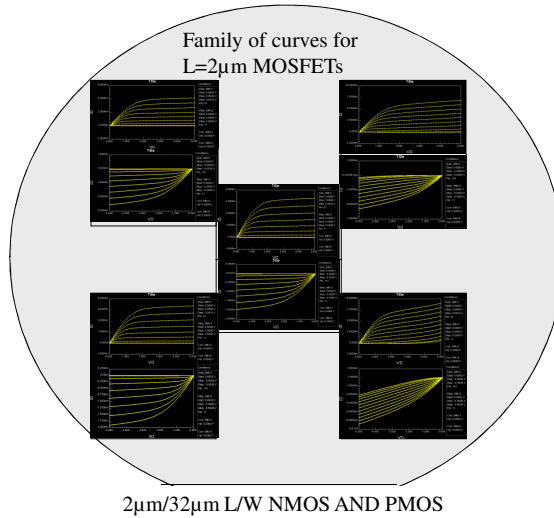
DIFFERENT LOOKING FAMILY OF CURVES AT DIFFERENT LOCATIONS ON THE WAFER

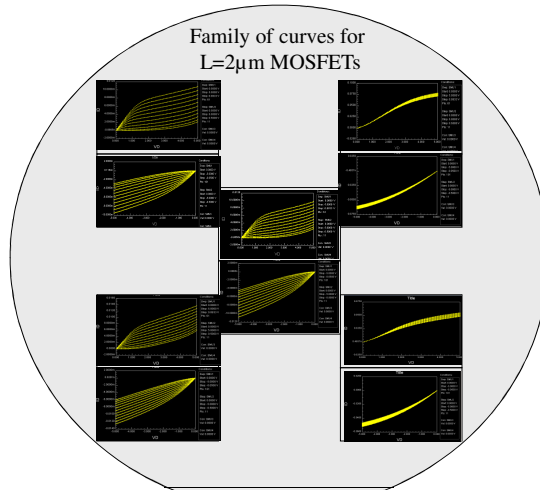
NON UNIFORMITY IN PLASMA ETCH OF POLY

2µm/32µm L/W NMOS AND PMOS

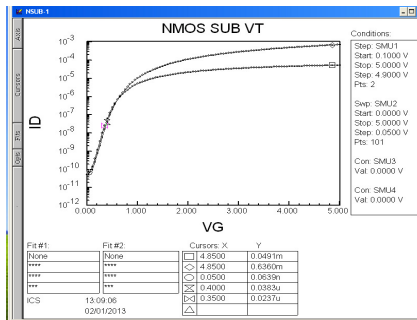
GOOD DEVICE SUB THRESHOLD CHARACTERISTICS

Occasionally our 1µm Devices Work
Why does the sub-threshold plot not flatten out at the bottom?

Answer: V_t is ~0.5 volt and swing is ~100mV/decade so at zero volts the device can be down 5 decades of current which is 10^{-10} it should flatten out at $\sim 10^{-11}$ or 10^{-12} need higher V_t or smaller swing

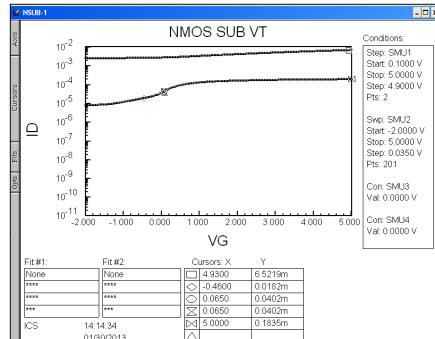
SHORT CHANNEL – BAD SUB THRESHOLD

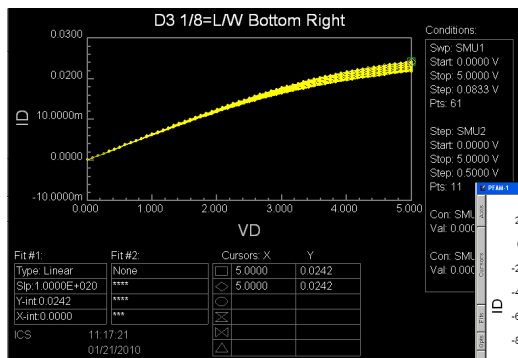
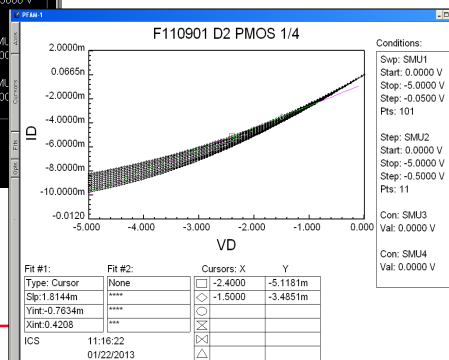
REALLY SHORT CHANNEL

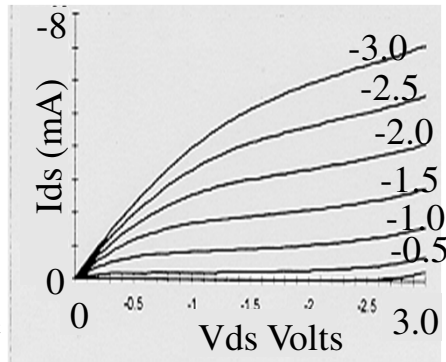
RIT's FIRST SUB MICRON TRANSISTOR

Mark Klare 7/22/94 Electron beam direct write on wafer, n-well process 5E12 dose, P+ Poly Gate PMOS, shallow BF2 D/S implant, no Vt adjust implant.

L=0.75 μm
 $X_{\text{ox}}=300 \text{ \AA}$
 D/S $X_j = 0.25 \mu\text{m}$
 P+ poly
 Nd well $\sim 3\text{E}16$

$V_t = -0.15$
 Sub Vt Slope=130 mV/dec

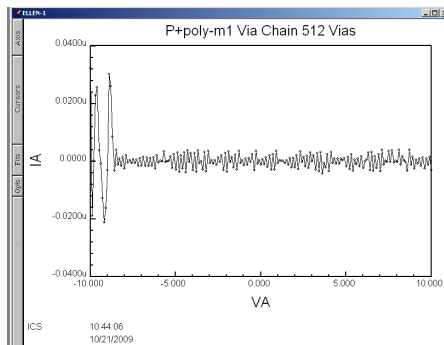
NO
 Open Circuit, both electrical and visual evidence

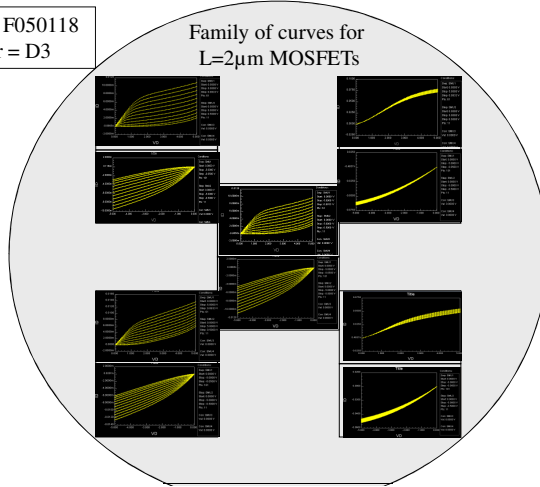
NON UNIFORMITY IN PLASMA ETCH OF POLY

Lot Number = F050118
Wafer Number = D3

Family of curves for
L=2 μ m MOSFETs

2 μ m/32 μ m L/W NMOS AND PMOS

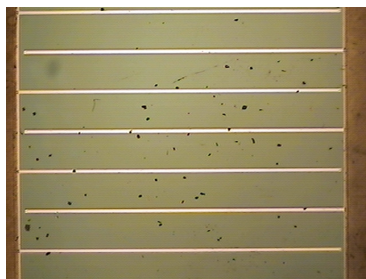
LARGE 5mm X 5mm PHOTODIODE

Isc = 0.15mA (short circuit current)
or 9.09 A/m²

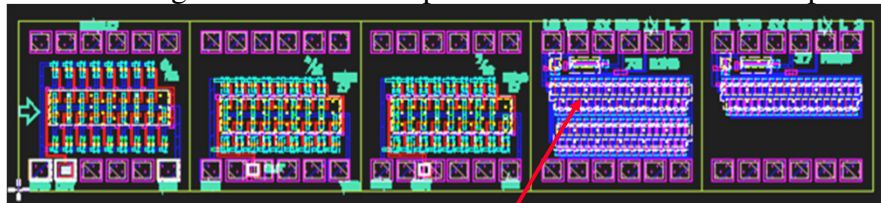
RING OSCILLATOR LAYOUTS

17 Stage Un-buffered Output L/W=2/30 Buffered Output
