Quantitative image analysis of white etching areas in SAE52100 bearing steel

Philippe T. Pinard¹, Mehmet Özel², Moritz Ploß³ and Silvia Richter¹

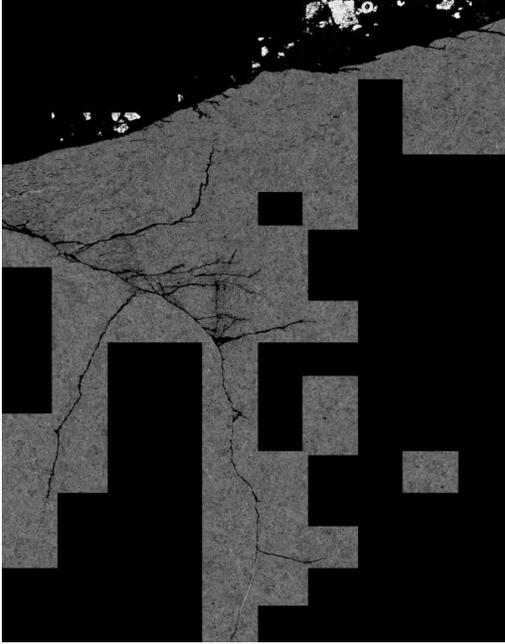
Figure 1: Result of the automated acquisition of high resolution images along the cracks.

For the characterization part, it was clear from the beginning that many samples and large areas would need to be observed. The established strategy was to section the failed bearing where pitting or scuffing appears on the contact surface, locate cracks and WEAs using a light optical microscope after polishing and Nital etching, slightly re-polish the surface to remove the etching, and insert the sample in a scanning electron microscope for high resolution images and chemical information. As WEAs can be quite small, the acquisition of electron images was required to ensure an unbiased identification. To facilitate the acquisition, a program was developed to first acquire low magnification images over a large area, detect cracks and then automatically acquire high magnification images along the cracks. A mosaic image resulting from this acquisition is shown in Figure 1.

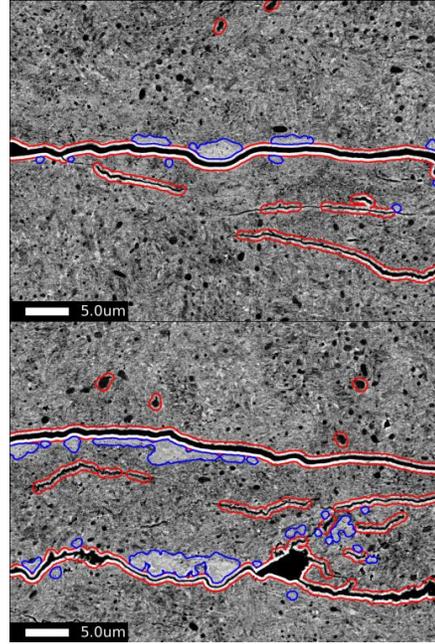
Figure 2: Examples of the image analysis routine used to automatically detect cracks (red) and white etching areas (blue).

The next step was to identify the WEAs from the surrounding matrix and cracks using an image analysis routine. The goal is to statistically compare the WEAs found in different cross-sections based on potential criteria such as their size, shape, quantity, distance from the surface, etc. The developed image analysis routine utilized the fact that WEAs contain very small grains [2] and therefore appear brighter in a backscattered electron image due to lower electron channelling. The image analysis methodology goes as follows (Figure 2): thresholding to identify the cracks (low intensity pixels), morphological dilation of the identified cracks to remove edge effects (topographical effects), removal of the cracks from the original image, median filter to remove noise, smoothing to remove intensity fluctuations in the matrix, thresholding of WEAs using a random-walk algorithm and finally removal of false positive WEAs based on the criterion that WEAs should be close to a crack. All image processing procedures were written in Python with the scikit-image library [3].

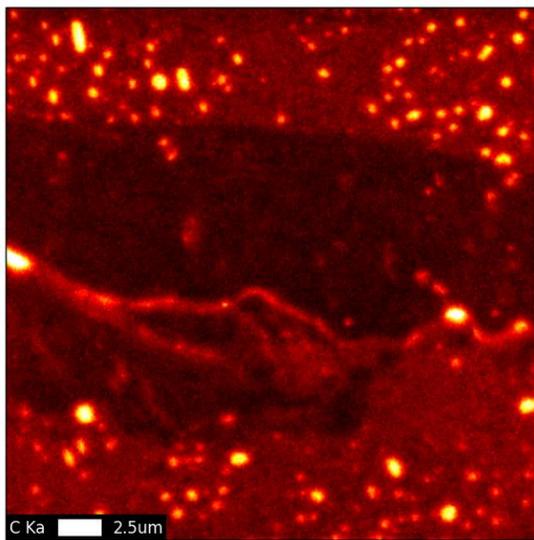
Figure 3: Qualitative carbon (a) and chromium (b) mapping of a white etching area.

Chemical information of the WEAs and their surroundings was obtained using a field emission electron microprobe (JEOL JXA8530F). This instrument was also used for the image acquisition. As indicated in [4], quantification of the carbon concentration in SAE52100 is challenging due to the high concentration of chromium. As preliminary results, a lower carbon concentration was observed in the WEAs than in the surrounding matrix (Figure 3). Further analysis of the composition as well as examples of failed bearings under different operating conditions will be presented.
